Metrolink

PREVENTATIVE MAINTENANCE ON METROLINK

Dr Martyn Chymera

Head of Engineering and Asset Management

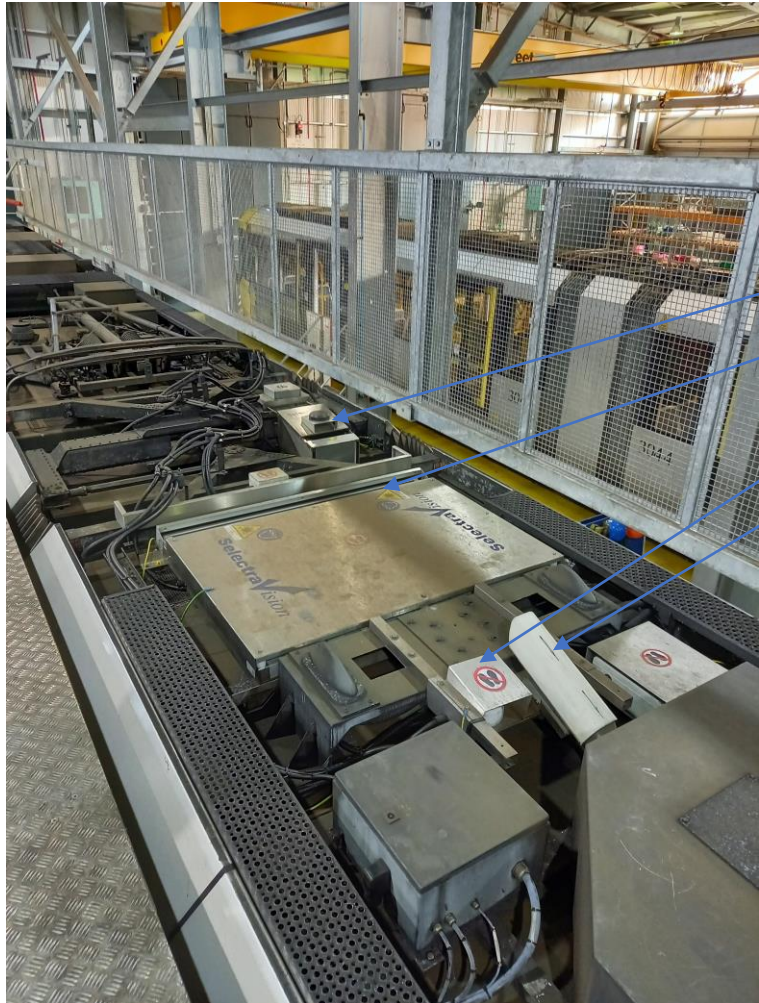
Remote Condition Monitoring – Overhead Line Measurements

- Rotating Laser (lateral and vertical position)
- Light reflection (lateral position and wear)
- Video – pantograph and side view
- Thermal camera

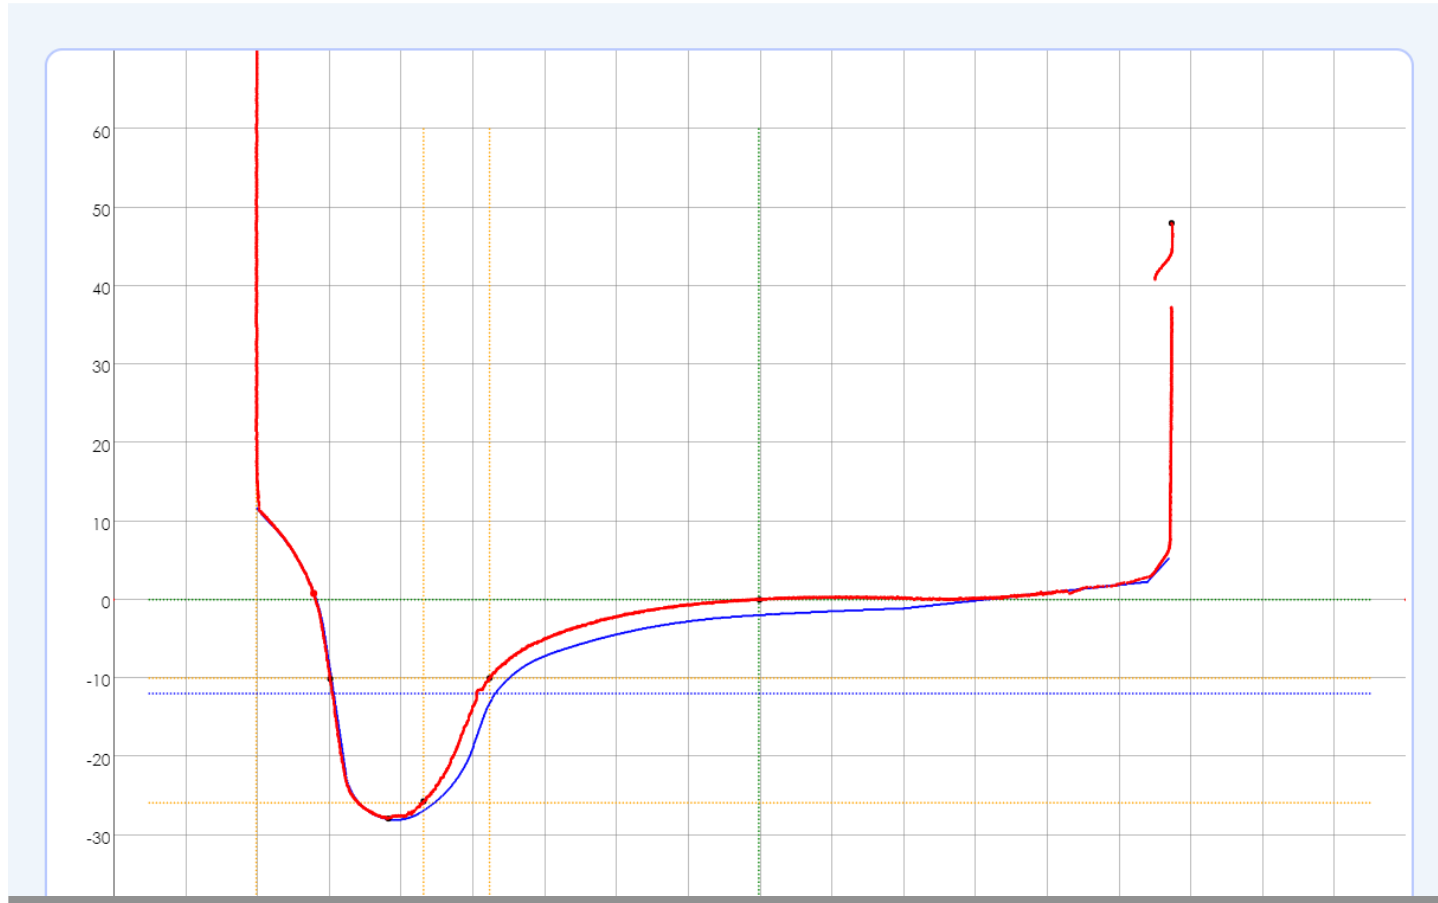
Wheel Profile Measurement

Vehicle Side	Width	Height	Quote q_r	Single Wheel	Axle difference
right	32.5	27.9	9.2	37.9	0.1

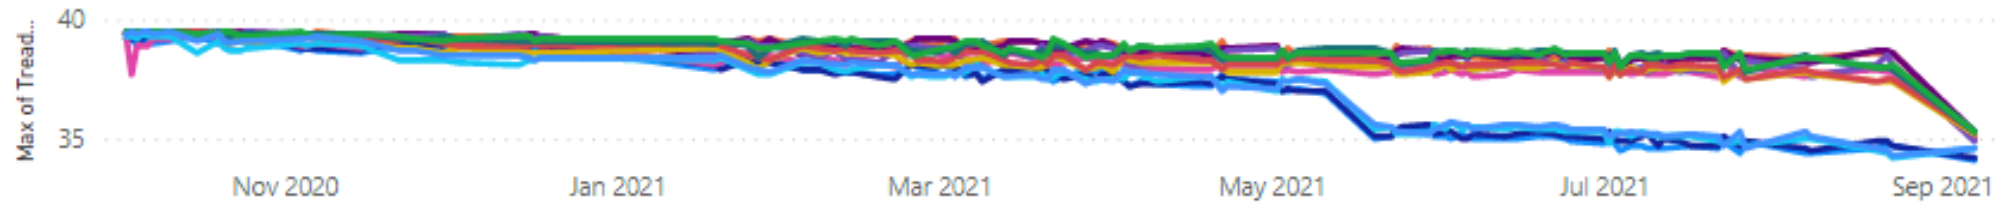
Max of Tread Depth (mm) by Transit Date and Wheel ID

Wheel ID ● 1 ● 2 ● 3 ● 4 ● 5 ● 6 ● 7 ● 8 ● 9 ● 10 ● 11 ● 12

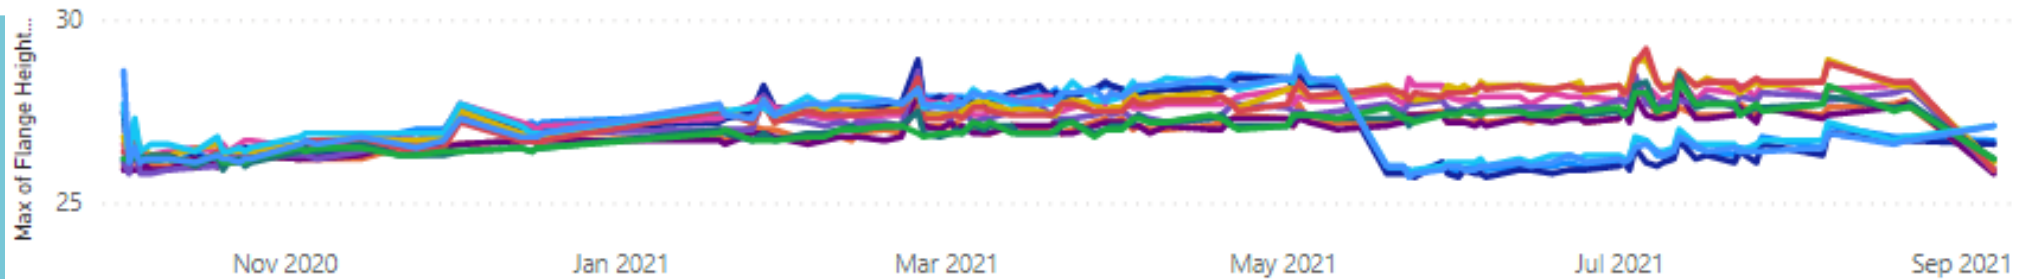
Max of Flange Height (mm) by Transit Date and Wheel ID

Wheel ID ● 1 ● 2 ● 3 ● 4 ● 5 ● 6 ● 7 ● 8 ● 9 ● 10 ● 11 ● 12

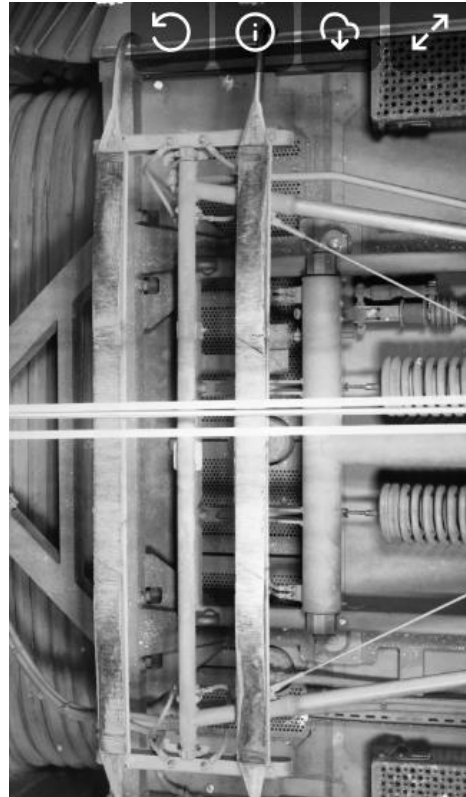
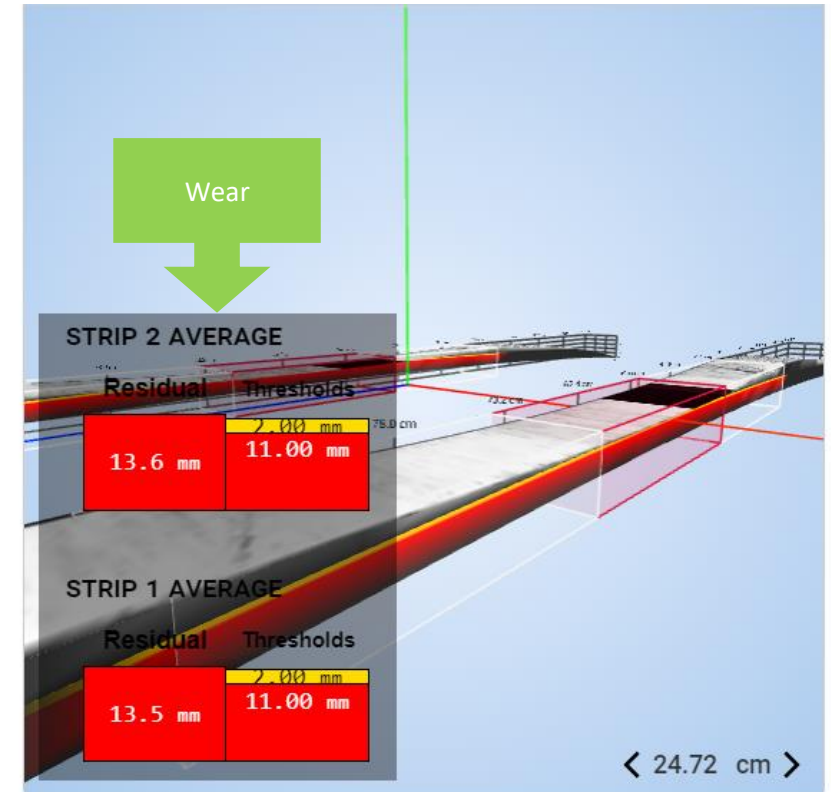
Pantograph Monitoring

- Type and degree of carbon wear
- Carbon defects – chipping, holes, cracks
- Pantograph head position – orientation, pitch, yaw
- Arc horn positioning
